Decision

Rescinding of two contracts for road and sidewalk snow clearing (call for tenders 16-15049)

June 17, 2019

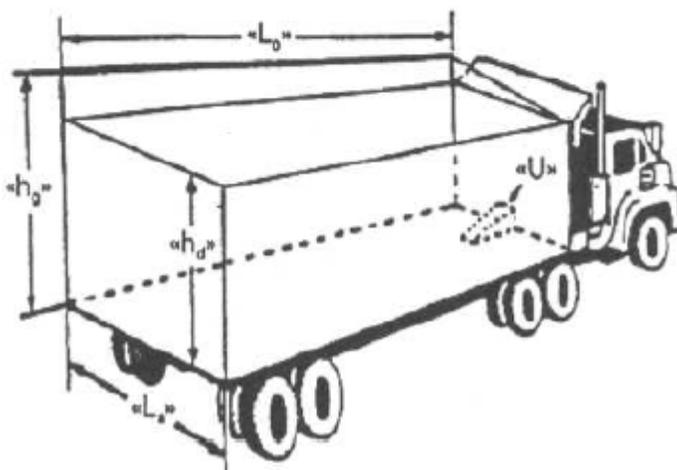
- **Volume** : est exprimé en mètres cubes, au dixième (1/10) près.
- **h_d** : Profondeur intérieure de la benne du côté droit du camion exprimée en mètres, au centimètre près;
- **h_g** : Profondeur intérieure de la benne du côté gauche du camion exprimée en mètres, au centimètre près;
- **L_a** : Largeur intérieure de la benne du camion exprimée en mètres, au centimètre près;
- **L_o** : Longueur intérieure de la benne du camion exprimée en mètres, au centimètre près;
- **U** : Saillie

Image taken from call for tenders 16-15049 specifications

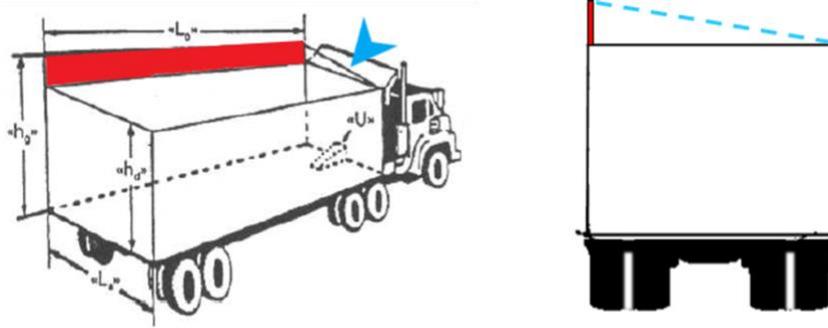
A figure is provided below to facilitate the reader's understanding. Using the figure from the call for tenders 16-15049 specifications, the second figure represents a cross-section from the rear of the truck. The red segment shows the planks often installed by truck drivers. This addition, made of wood or another material, extends above the truck's dump bed and helps prevent blown snow overshooting the bed and landing on cars parked on the opposite side of the street.

When Ville de Montréal wants to measure the expected dump bed volume, it not only calculates the contents of the dump bed itself, but also takes into account the snow extending above the dump bed up to the dotted blue line.

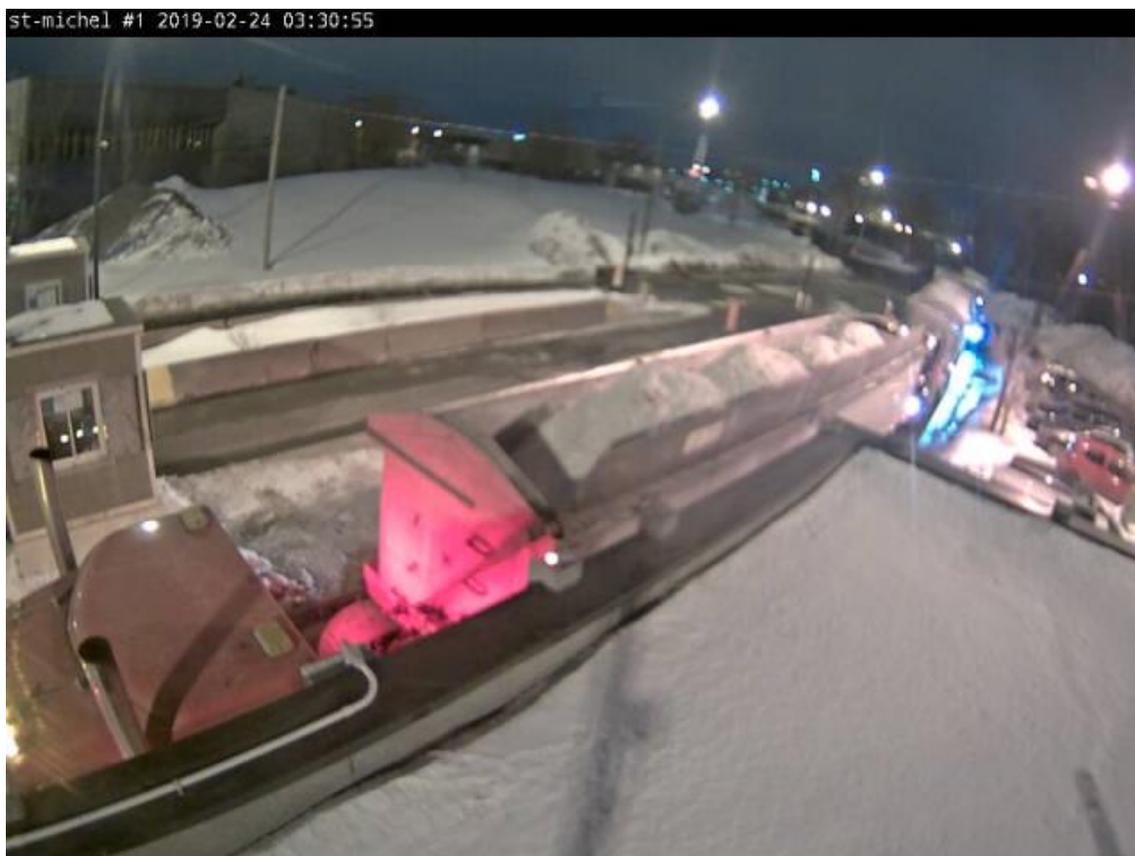
The first photo shows a load considered full for the purposes of the Office of Inspector General's analysis. The three (3) mounds referred to by the snowblower operators and Transport Rosemont under item 3.2.4 above can be clearly seen.

Load of snow originating from Sector 103 in the VSMPE borough considered full for the purposes of this case. Photo provided to the Office of Inspector General by the SCA.

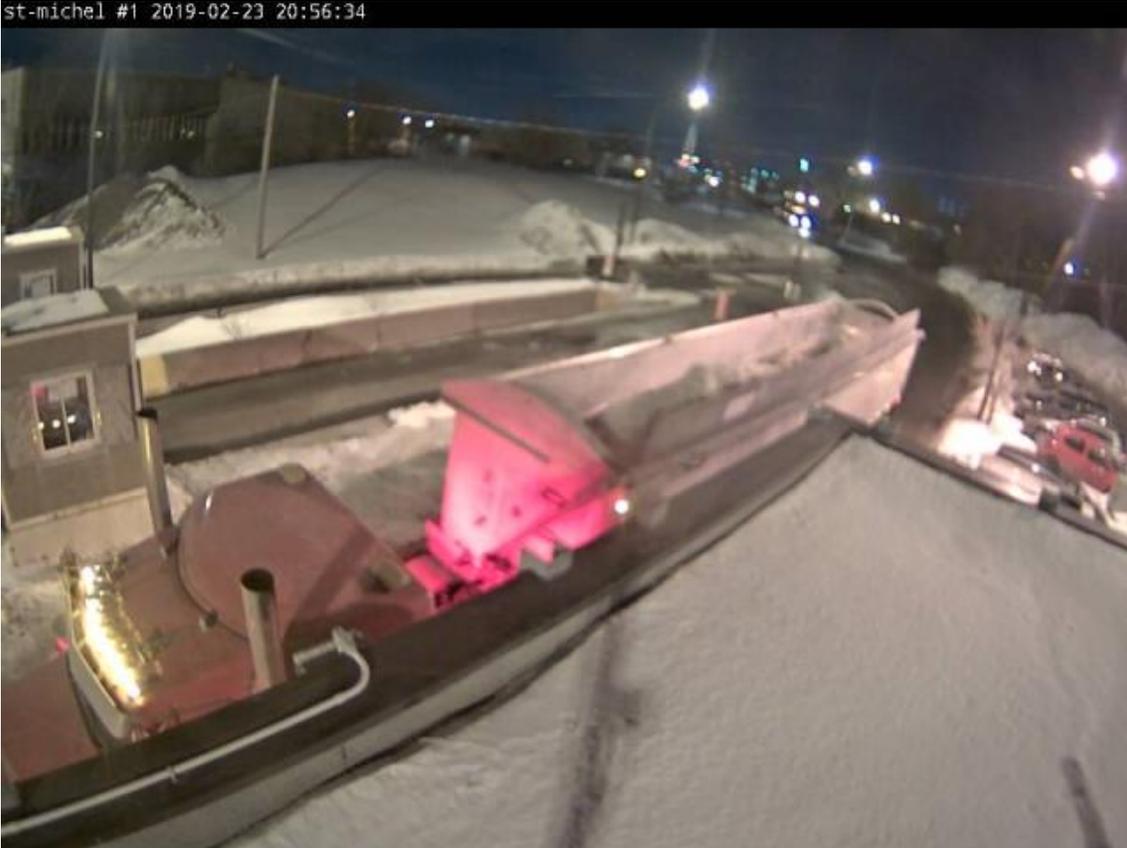
st-michel #1 2019-02-23 20:56:34

*Snow load originating from Sector 103 in the VSMPE borough part of the "50%" category.
Photo provided to the Office of Inspector General by the SCA.*

Unlike the previous image, it can be seen that the level of snow in the truck's dump bed is not flush with the side, as it should be based on the earlier photo. The snow only reaches about the middle of the truck's dump bed.

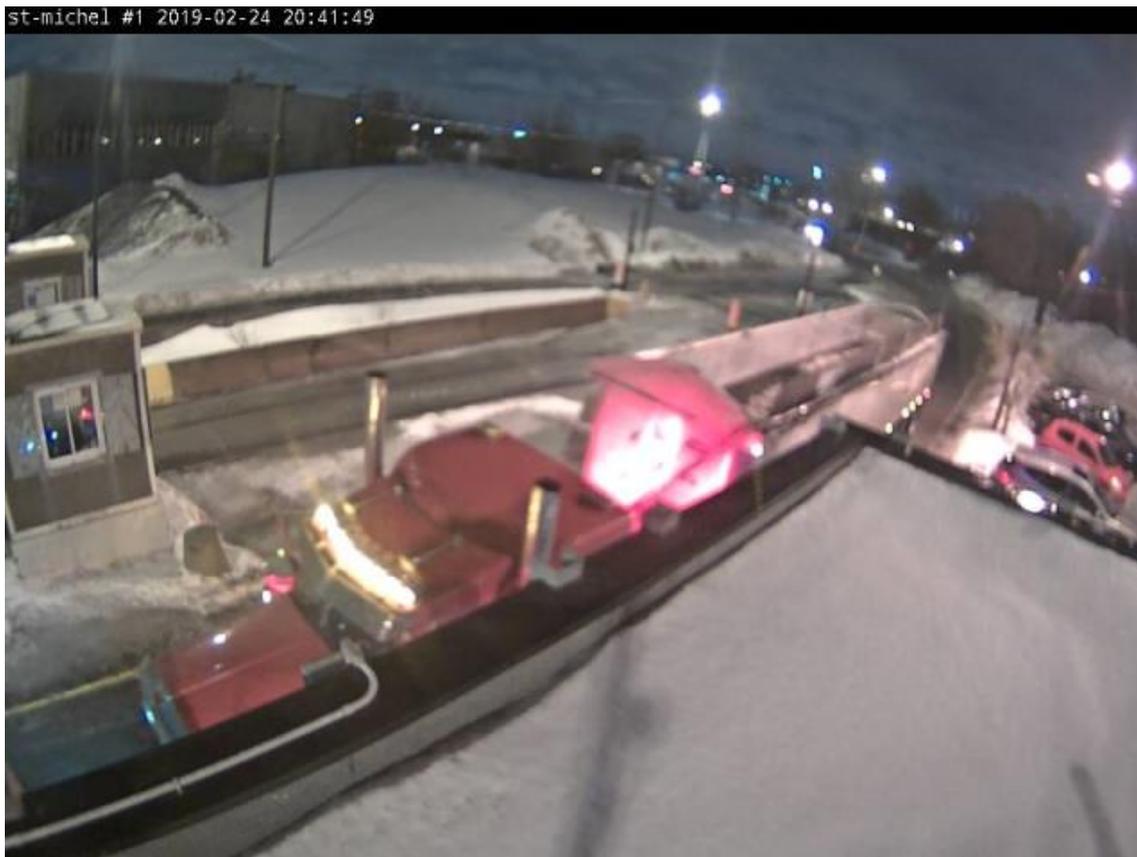
*Snow load originating from Sector 103 in the VSMPE borough part of the “10%” category.
Photo provided to the Office of Inspector General by the SCA.*

This photo shows a small amount of snow in the truck dump bed.

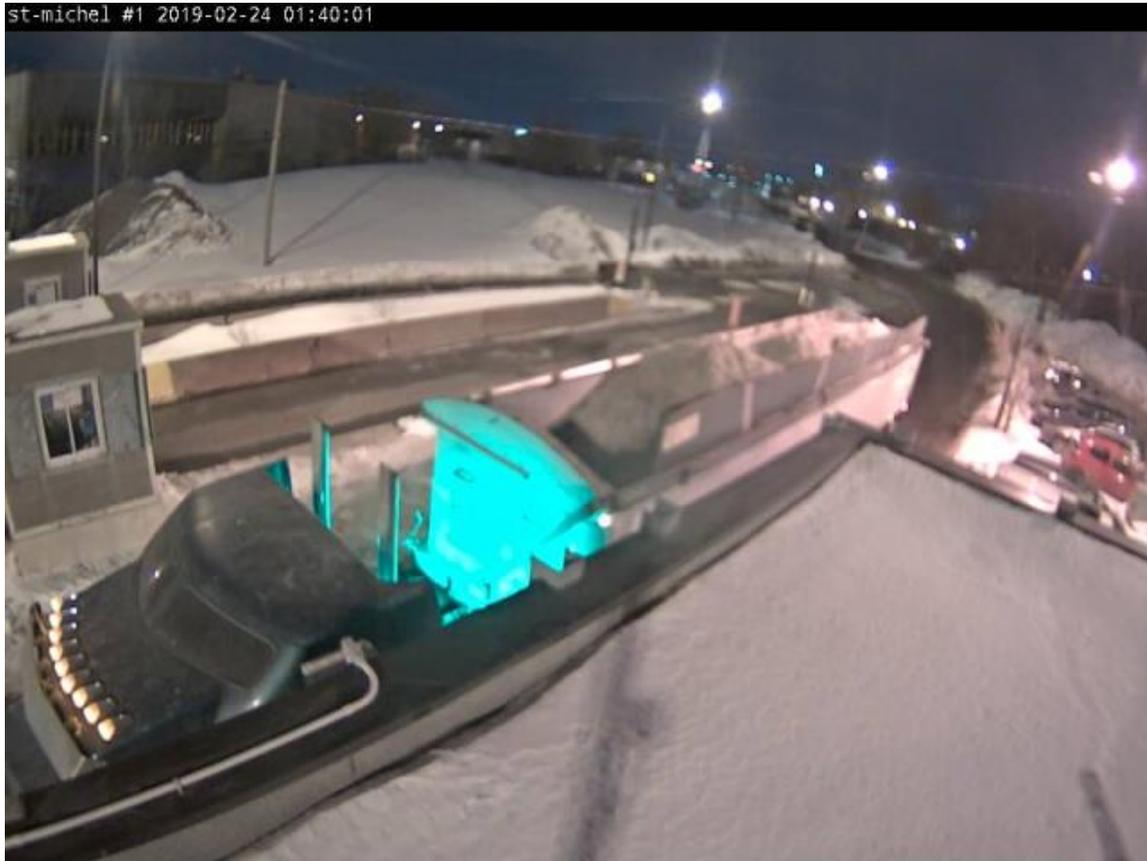
Load of snow originating from Sector 107 in the VSMPE borough considered full for the purposes of this case. Photo provided to the Office of Inspector General by the SCA.

As in the photo showing a full dump bed in Sector 103, the image shows the two (2) or three (3) mounds of snow rising above the dump bed which the snowblower operators and Transport Rosemont foremen had referred to in subsection 3.2.4 above.

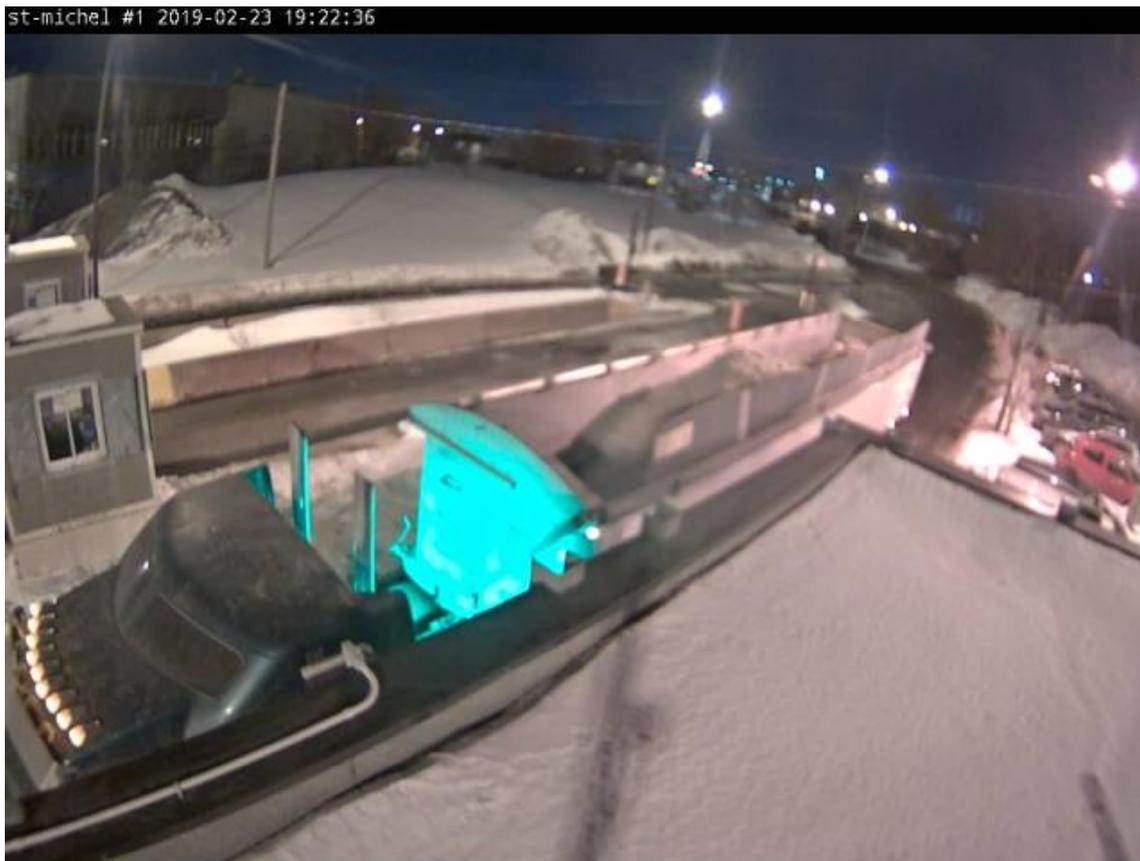
*Snow load originating from Sector 107 in the VSMPE borough part of the “50%” category.
Photo provided to the Office of Inspector General by the SCA.*

This photograph shows a mound of snow in the middle that is almost as high as the dump bed, but not enough snow at the front and rear of the dump bed.

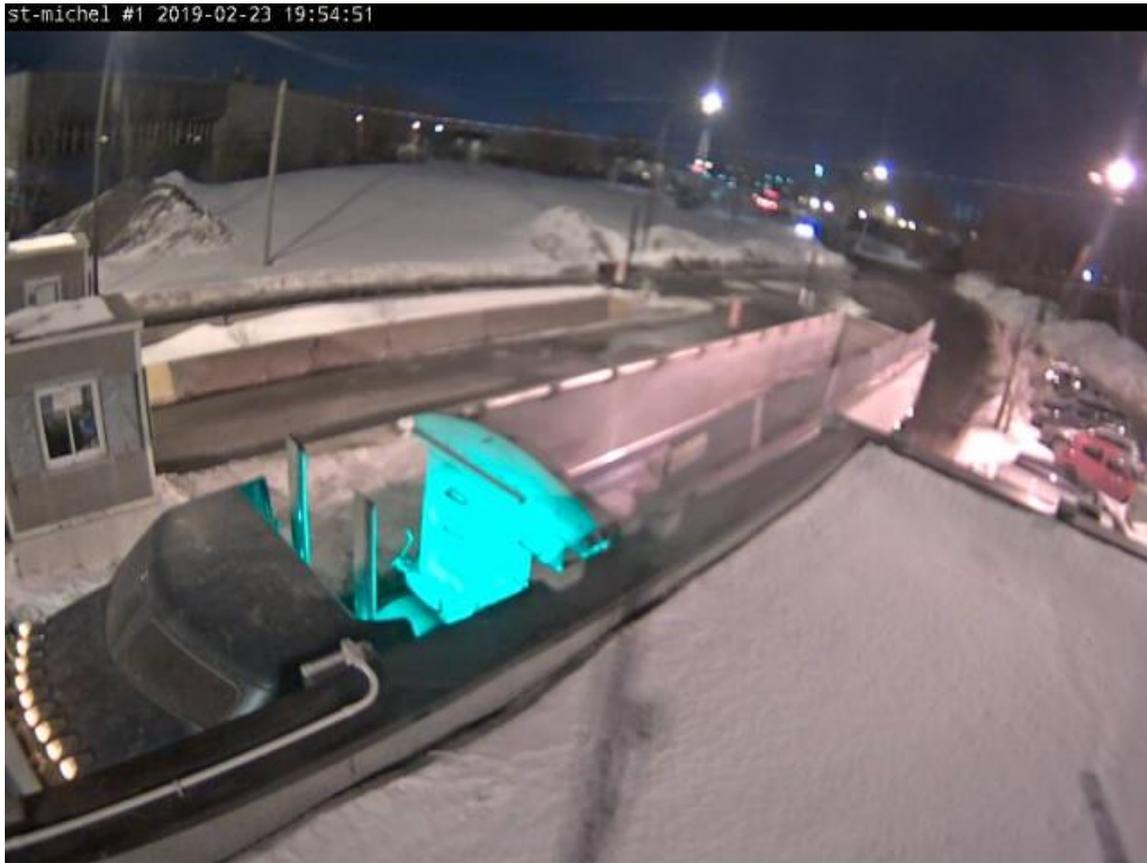
*Snow load originating from Sector 107 in the VSMPE borough part of the “10%” category.
Photo provided to the Office of Inspector General by the SCA.*

Like Sector 103, the photo shows that this load only contains a small amount of snow at the bottom of the dump bed.

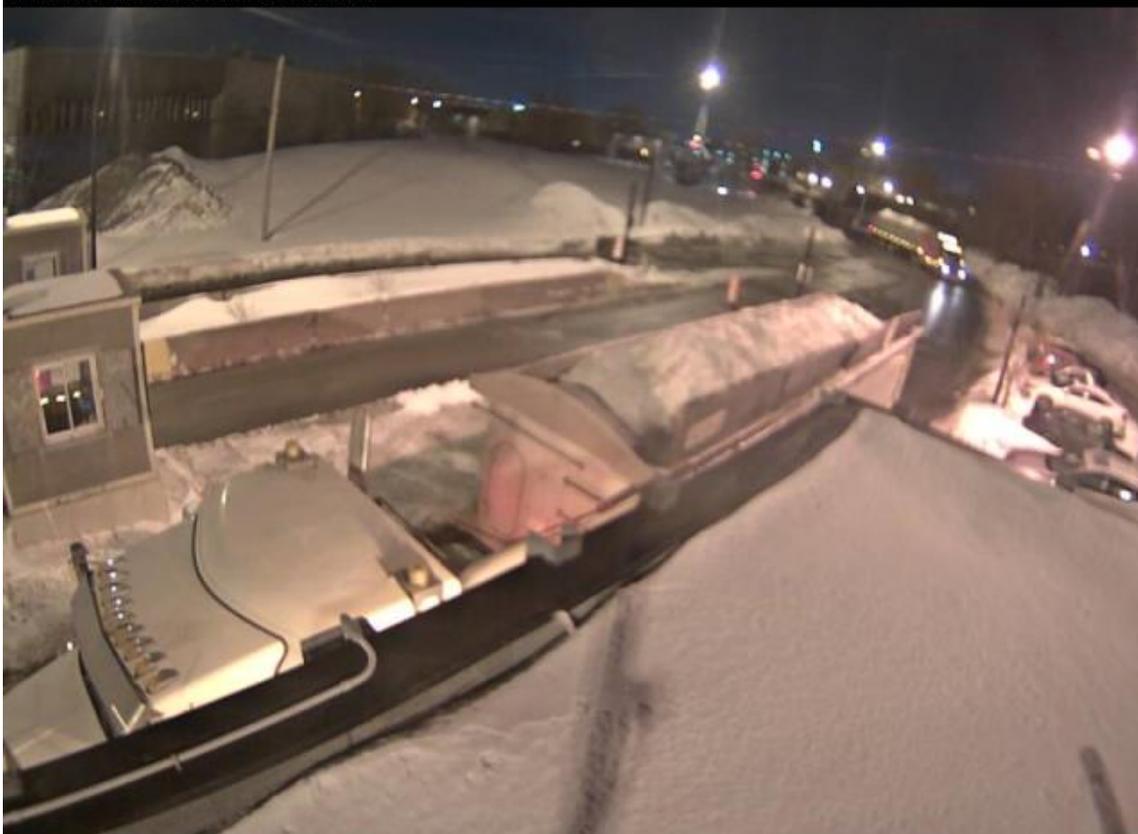
st-michel #1 2019-02-23 01:23:39

Load of snow originating from Sector 102 in the VSMPE borough considered full for the purposes of this case. Photo provided to the Office of Inspector General by the SCA.

Just as in the photos of the loads considered full in Sectors 103 and 107, it can be seen that the snow formed mounds that exceeded the height of the dump bed, in accordance with the dump bed measurement method described in subsection 3.1.2 above.

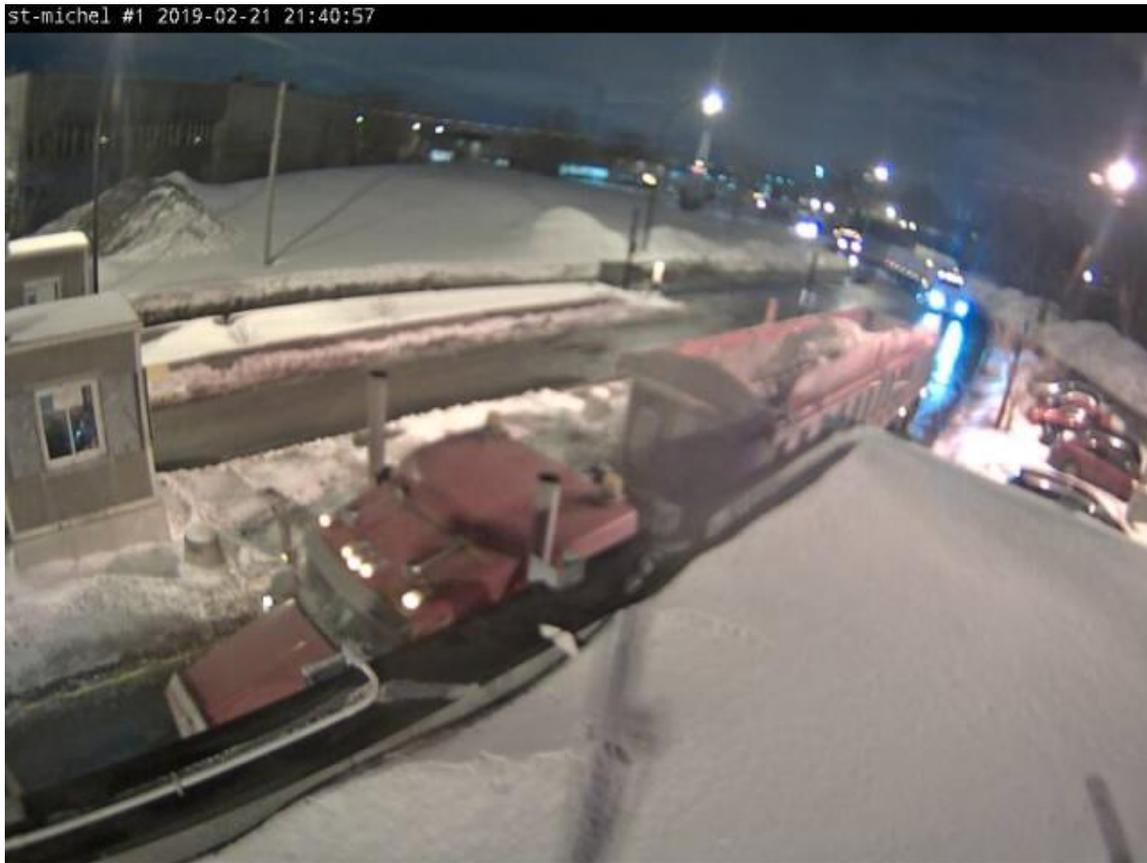
Next, there is a photo of a load estimated at approximately 50%, with a single mound of snow that can be seen toward the rear of the dump bed:

*Snow load originating from Sector 102 in the VSMPE borough part of the "50%" category.
Photo provided to the Office of Inspector General by the SCA.*

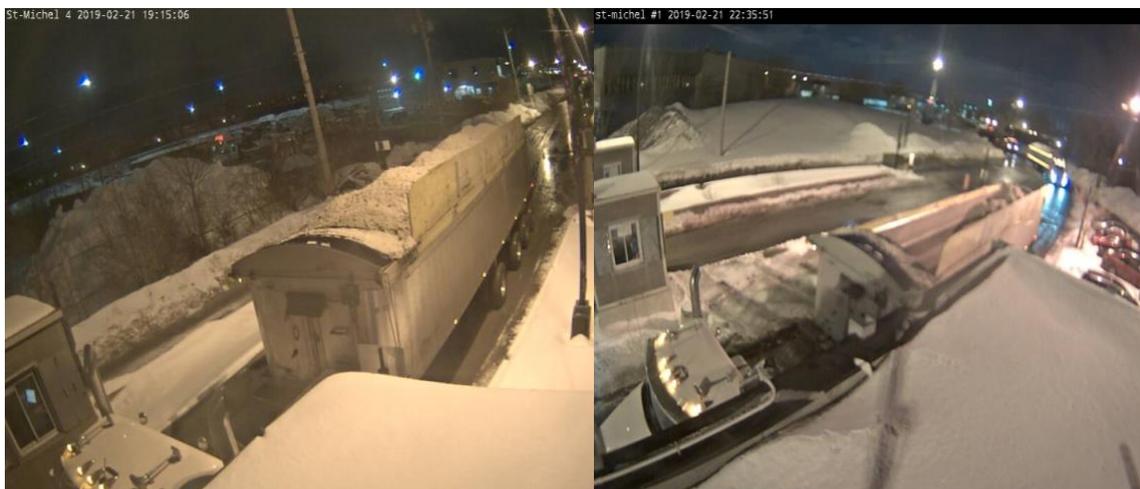
The following two photos show this double standard on the company's part according to the type of contract. A Transport Rosemont truck can be seen making trips with less than full loads in Sector 107, whereas only three hours earlier, the same truck was hauling full loads for a centimetres fallen contract in Ahuntsic-Cartierville.

*Left: Load of snow from the Borough of Ahuntsic-Cartierville at 7:15 p.m. on February 21, 2019.
Right: Load of snow from Sector 107 in the VSMPE borough at 10:35 p.m. that same day.
Photos provided to the Office of Inspector General by the SCA.*
