Recommendation Report Regarding a Snow Transport Subcontract

(section. 57.1.23 of the *Charter of Ville de Montréal, metropolis of Québec*)

October 22, 2019

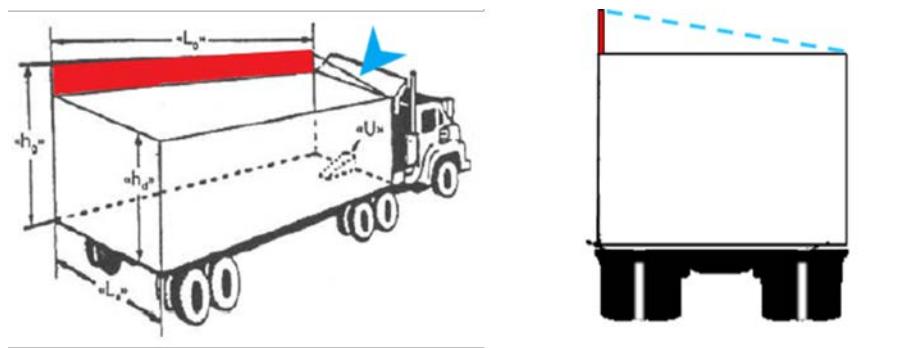
For a better understanding of this aspect, a figure is provided below. It shows a section through the rear of the truck. The red segment shows the side panel often installed by the truck drivers. This addition, made of wood or another material, exceeds the height of the bin and helps prevent blown snow from missing the truck bin and striking cars parked on the opposite side of the street.

When the City wants to measure the expected bin volume, it not only calculates the content of the bin itself, but also takes into account the snow exceeding the bin up to the dotted blue line.

This operation was done using a laser optical measuring instrument by a company whose services were retained by Ville de Montréal. This instrument captures a cloud of reference points in the bin to produce a 3-D digital image of it. It adds the bin volume as such to the volume defined by the triangle formed by the top of the bin, the left panel, and the blue dotted line.

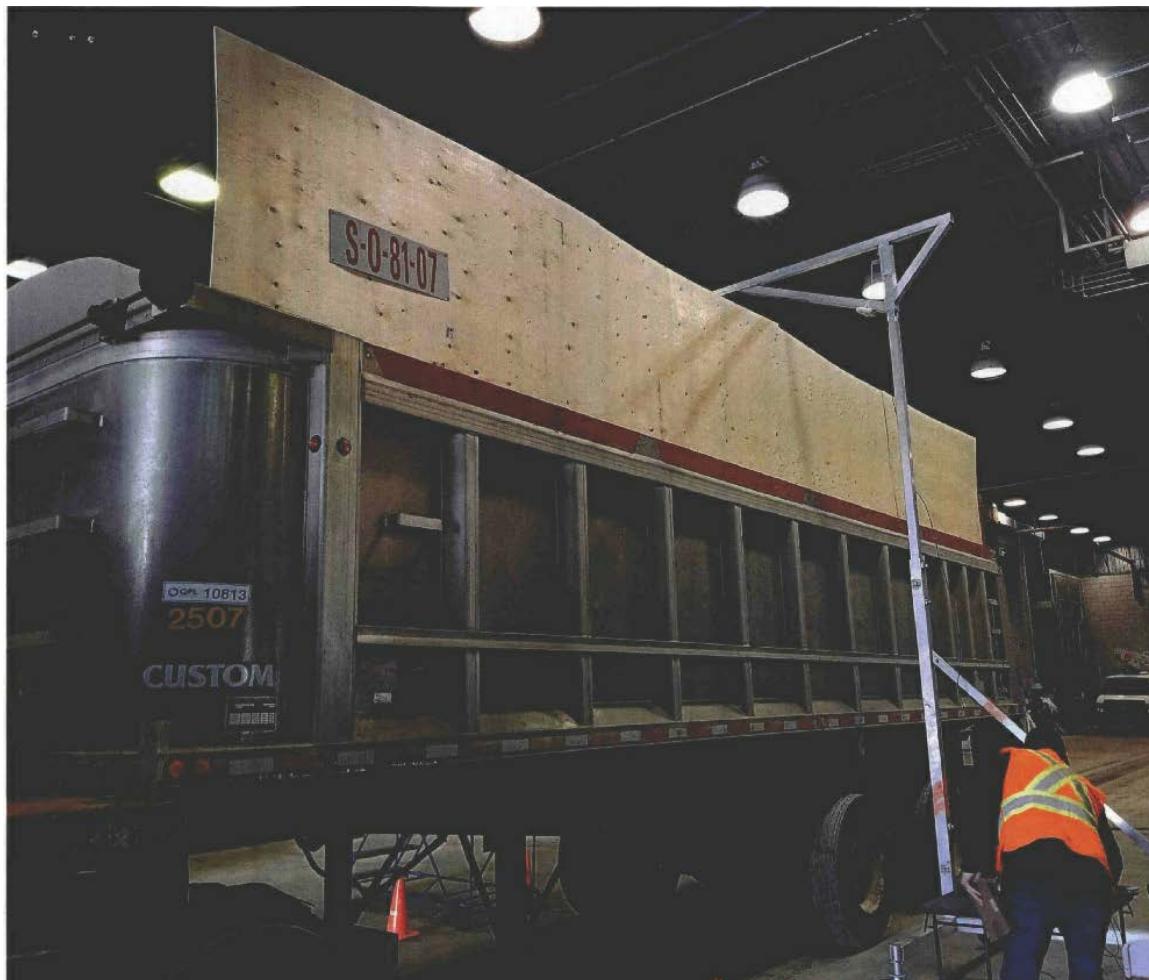
The third measuring session was held on March 9, 2019. The volume measured on this occasion was 56.16 m³, representing an increase of approximately 33% over the previous measurement.

However, as it appears in the photos below, which were taken during this measuring session, Sylvain Choquette had added wood panels above a smaller rounded red wood panel, thereby increasing his truck's bin capacity.

Photo taken from the outside of the Entreprise Sylvain Choquette inc. truck bin during the March 9, 2019, measuring session. Photo provided to the Office of Inspector General by the SCA.

It should be pointed out that the SCA observed the modification of the side panels. Thus as part of its payments to the bulk transport company, the SCA did not take into account the new measurements of the Entreprise Sylvain Choquette inc. truck obtained in the March 9, 2019, measuring session and instead used those from the January 11, 2019, session.

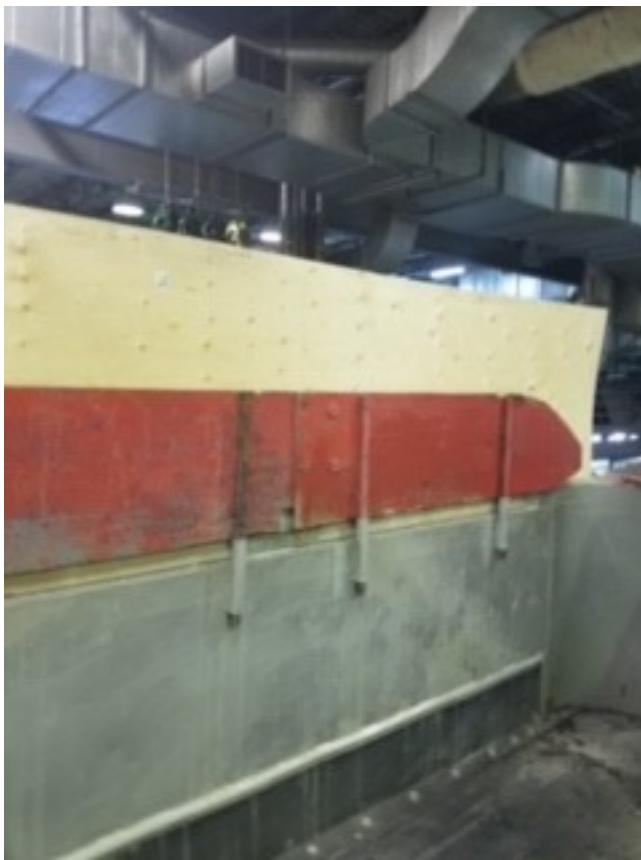
Photo taken from the inside of the Entreprise Sylvain Choquette inc. truck bin during the March 9, 2019, measuring session. Photo provided to the Office of Inspector General by the SCA.

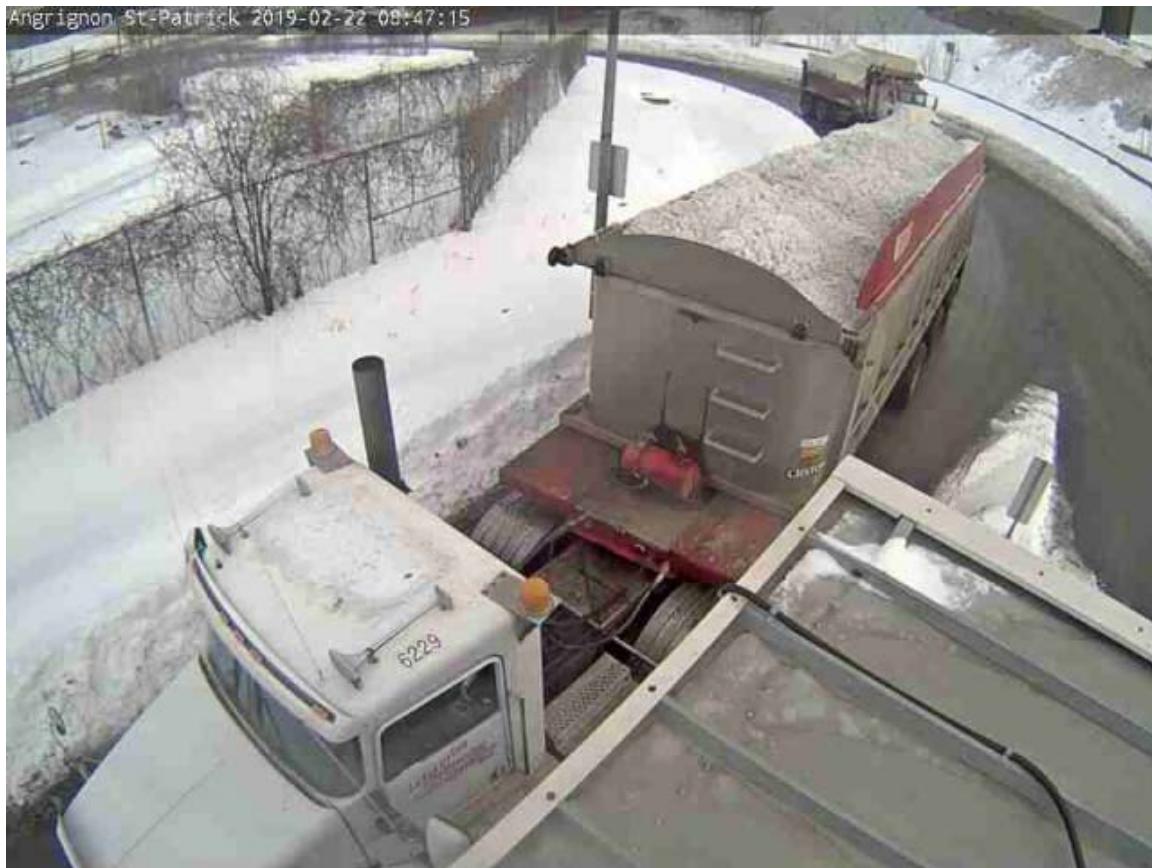
They show that the additional panels added by Sylvain Choquette at the time of the March 9, 2019, measuring session were not used during the snow loading operations. Only the smaller red rounded wood panel is visible, even on the photos taken after the March 9, 2019, measuring session.

Transport of snow by Entreprise Sylvain Choquette inc. on February 22, 2019. Photo provided to the Office of Inspector General by the SCA.

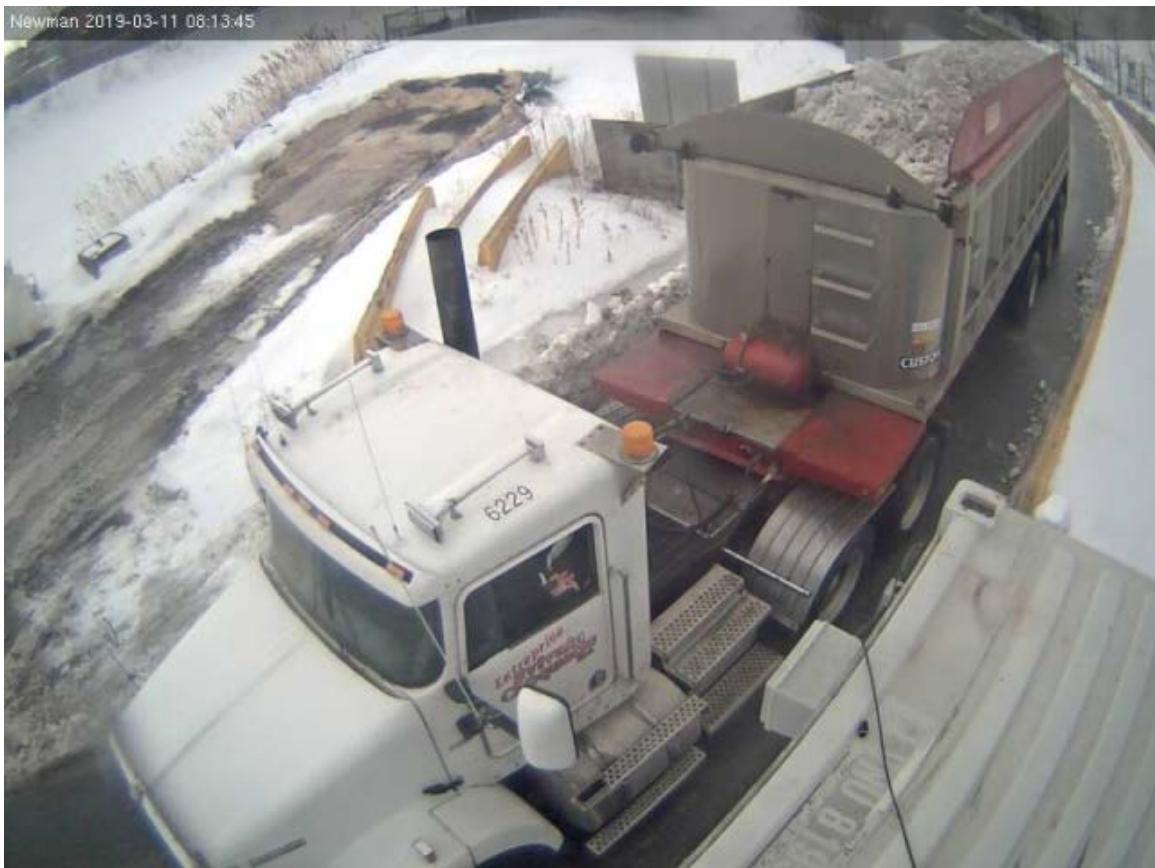
Transport of snow by Entreprise Sylvain Choquette inc. on March 11, 2019. Photo provided to the Office of Inspector General by the SCA.
